Newtown Community Association

A 'VISION'

A purpose built, exemplar ecological
Community Building for Newtown

Belmont Park

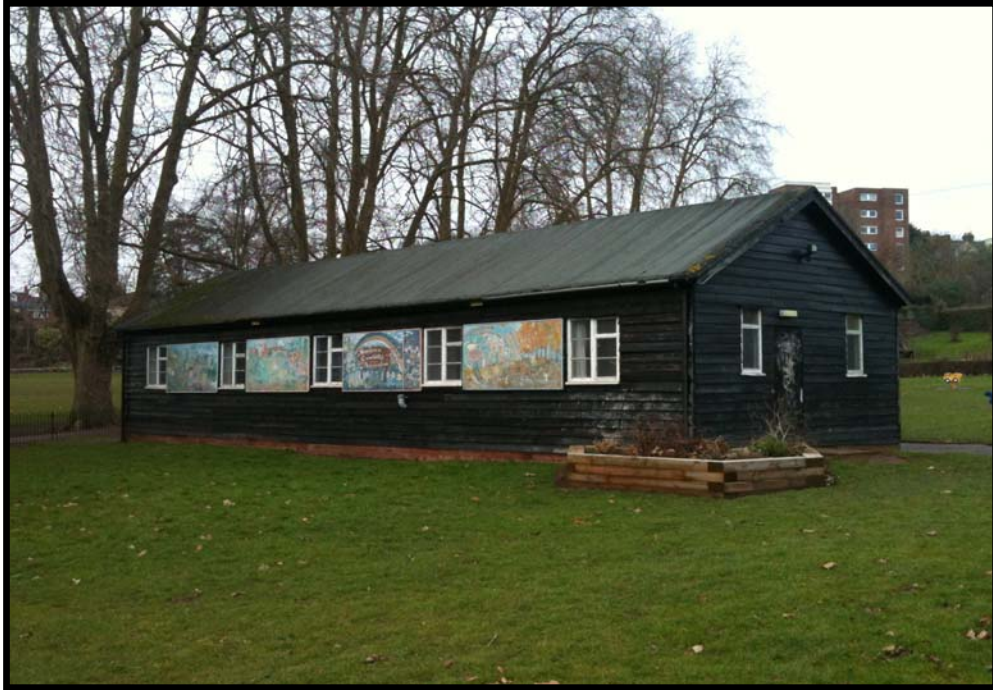
Existing Newtown Community Building

The NCA Building is a single storey building of 102m² with 2 main function rooms, a kitchen and only 2 WC's. It has a duo-pitch roof with a vaulted ceiling internally. The construction is a simple timber frame dating from post WWII and was not designed for its current purpose. Usage consists of various local groups of all ages and activities and occupancy is intermittent throughout the week.

It can be seen from below the building is very energy inefficient which impacts on the comfort of the users. As it was not designed with community facilities in mind is not very well laid out or welcoming to the public. There is no designated outside space and the facilities are limited. There are insufficient storage areas which impacts on the internal space and makes activities more difficult.

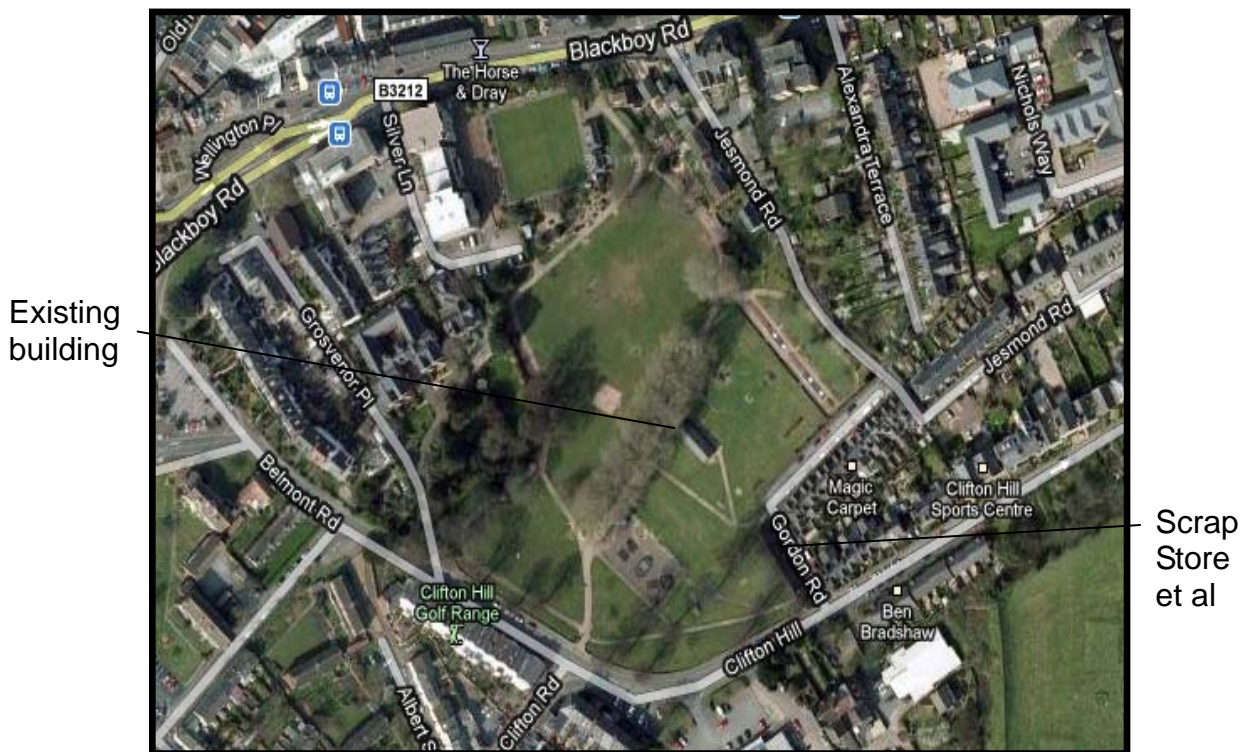
Site Plan

Existing building

Scrap Store et al

The building is situated in the centre of Belmont Park which is one of the oldest parks in Exeter (<http://www.exeter.gov.uk/index.aspx?articleid=7839>). The ward of Newtown has a population of approximately 4000 residents. The ward boundary follows Sidwell St. to the East, Iddesleigh Road to the North, Posloe Road to the West and Magdalen Road to the South. There are numerous schools from primary upwards to a University of Exeter campus, various shopping and recreational facilities including swimming pool, cinema, golf driving range and dry ski slope. There are two health centres and a maternity hospital. The population is mixed in terms of ages and cultures and the community centre is currently heavily used by numerous groups and associations.
