Newtown Community Association

A 'VISION'

A purpose built, exemplar ecological
Community Building for Newtown

Belmont Park

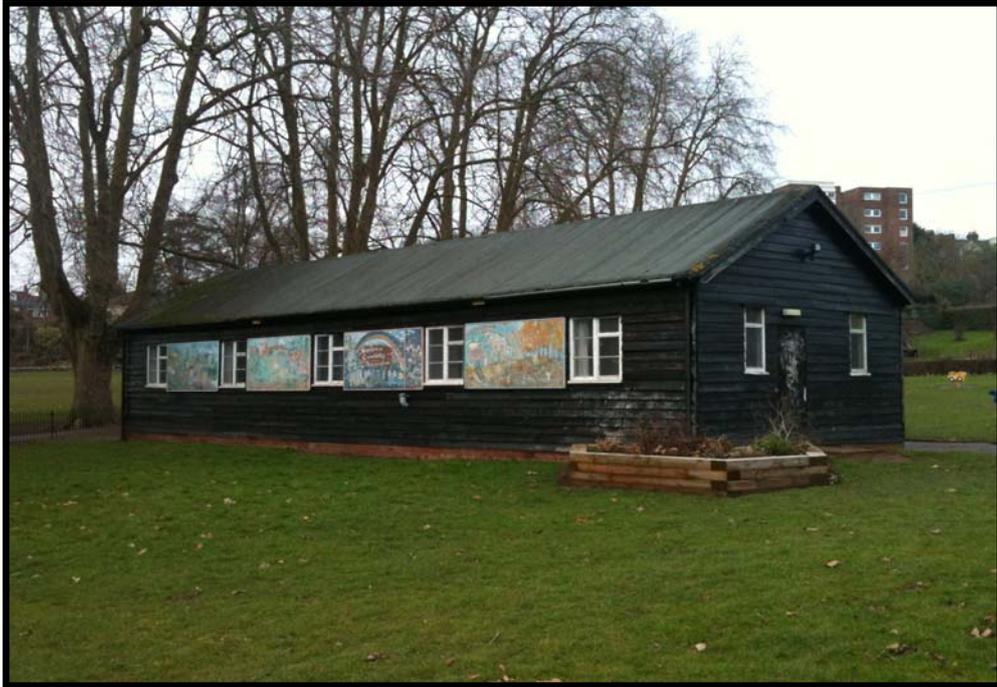
Existing Newtown Community Building

The NCA Building is a single storey building of 102m² with 2 main function rooms, a kitchen and only 2 WC's. It has a duo-pitch roof with a vaulted ceiling internally. The construction is a simple timber frame dating from post WWII and was not designed for its current purpose. Usage consists of various local groups of all ages and activities and occupancy is intermittent throughout the week.

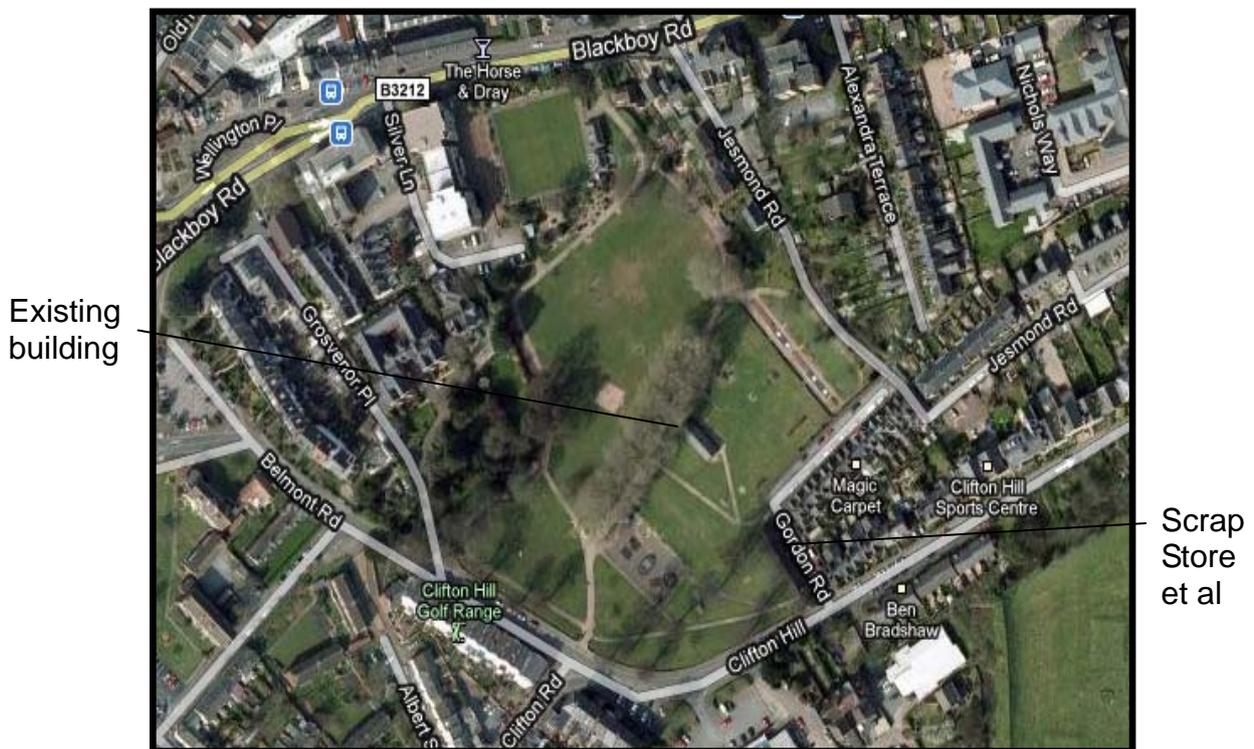
Site Plan

Existing building

Scrap Store et al
